## SURVEY REPORT

### VESSEL: "XXXX"

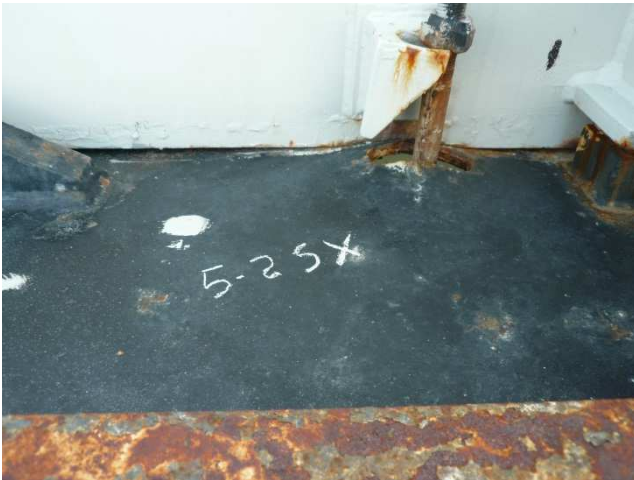
**Picture No.1 - C.H. No.5 Port side 2<sup>nd</sup> panel**

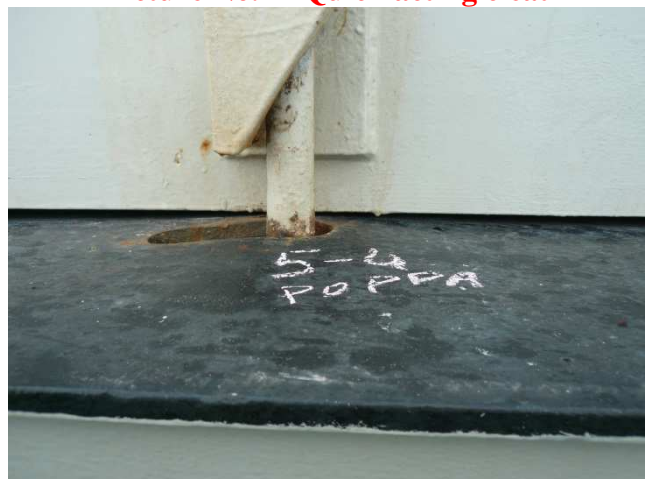
**Picture No.4 - Quick acting cleat**

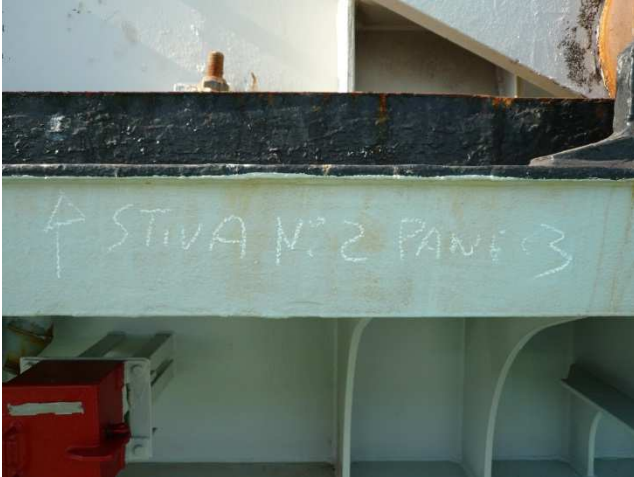
**Picture No.5 - C.H. No.2 Stbd side 3<sup>rd</sup> panel**

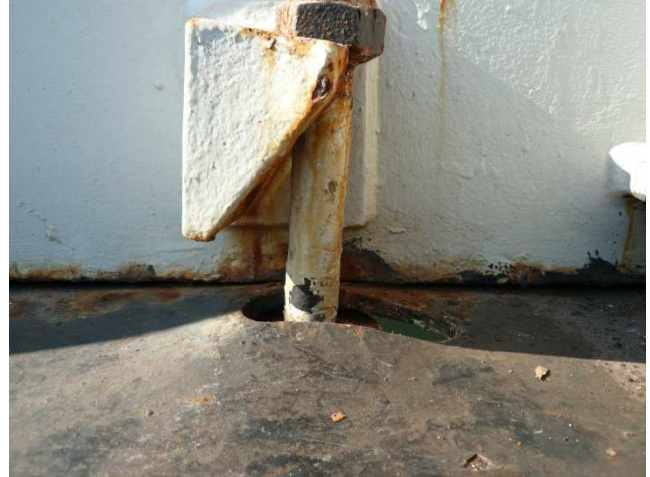
**Picture No.6 - Quick acting cleat**

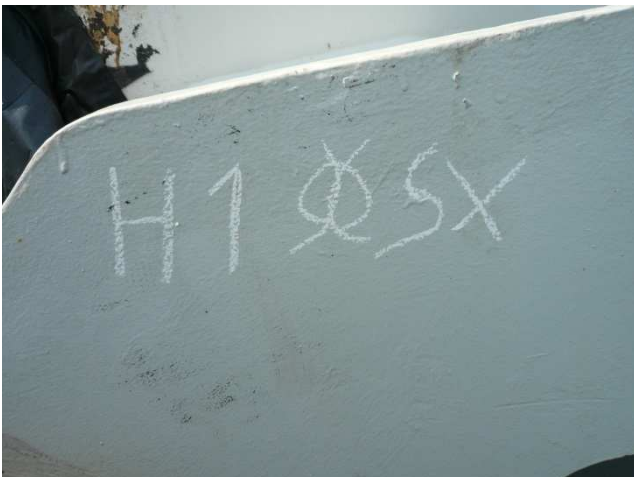
**Picture No.7 - C.H. No.1 Port side 2<sup>nd</sup> panel**

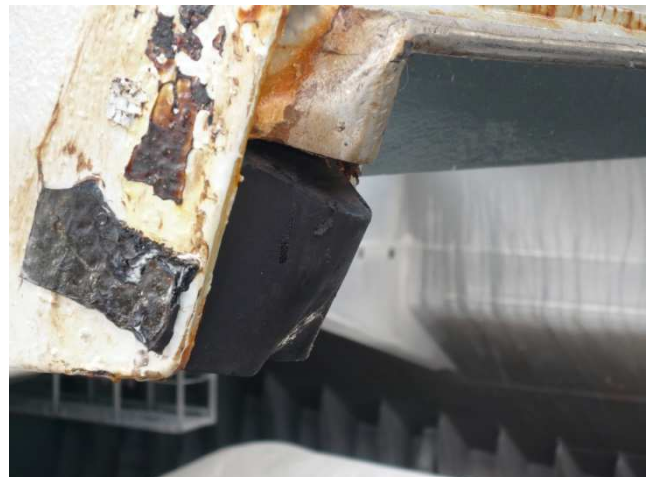
**Picture No.8 – rubber corner worn**

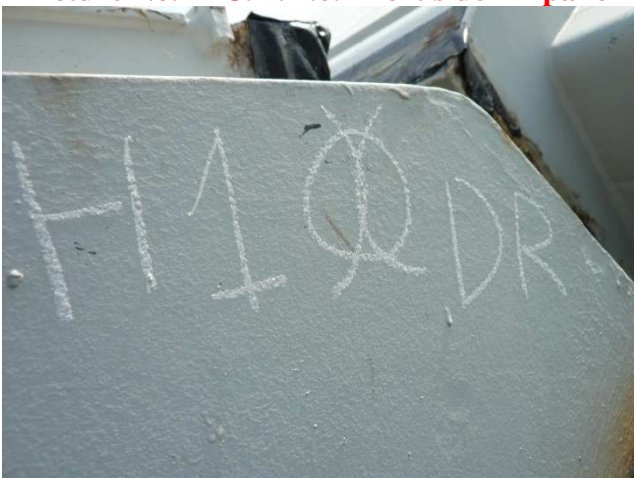
**Picture No.9 - C.H. No.1 Stbd side 2<sup>nd</sup> panel**

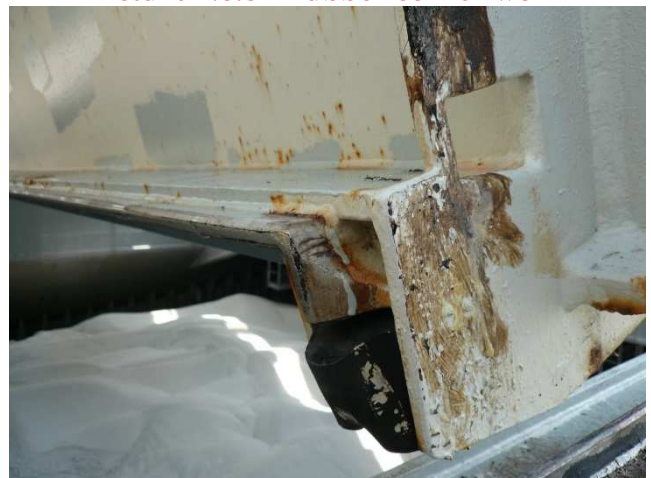
**Picture No.10 – 2<sup>nd</sup> panel rubber corner worn**

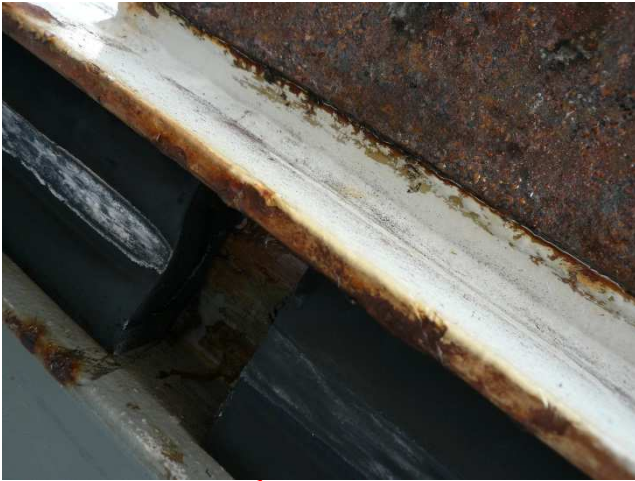
**Picture No.11 - 2<sup>nd</sup> panel missing rubber gasket**

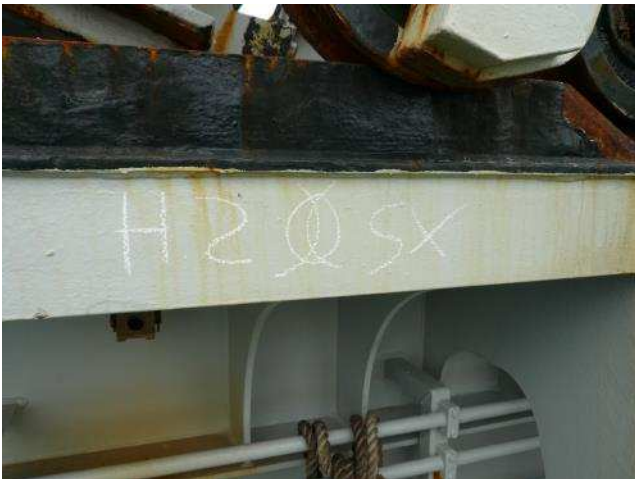
**Picture No.12 - C.H. No.2 Port side 2<sup>nd</sup> panel**

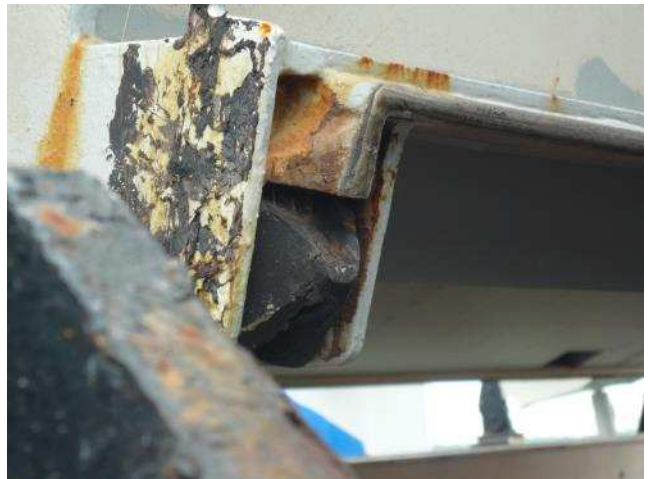
**Pict. No.13 – rubber corner damaged & worn**

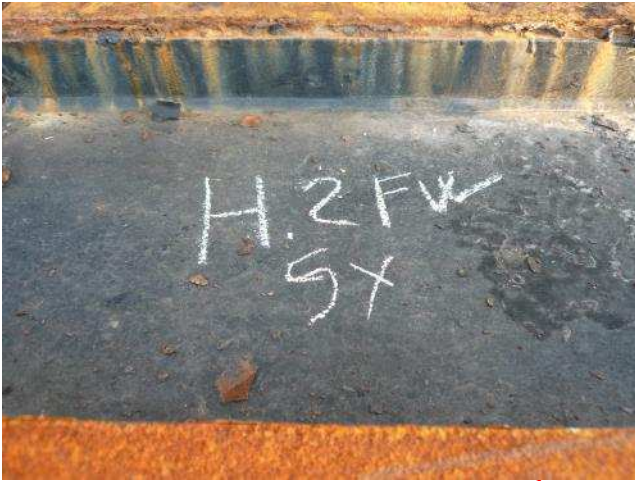
**Picture No.14 - C.H. No.2 Port side 2<sup>nd</sup> panel**

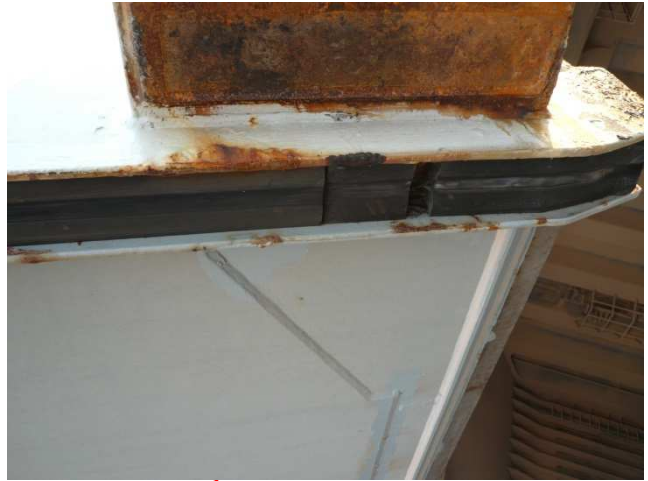
**Pict. No.15 -2<sup>nd</sup> panel, missing rubber gasket**

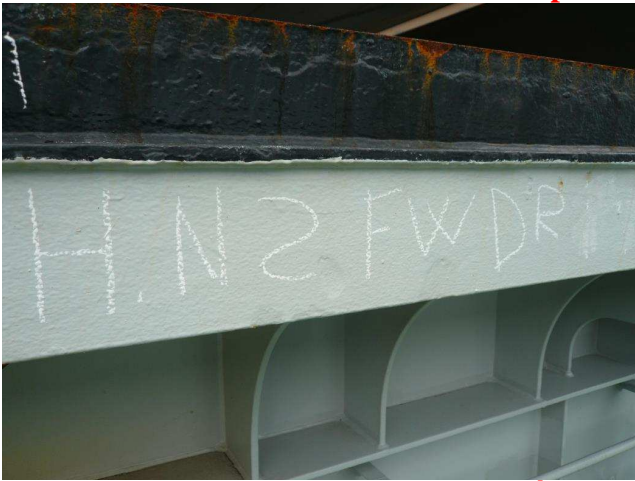
**Picture No.16 - C.H. No.2 Stbd side 2<sup>nd</sup> panel**

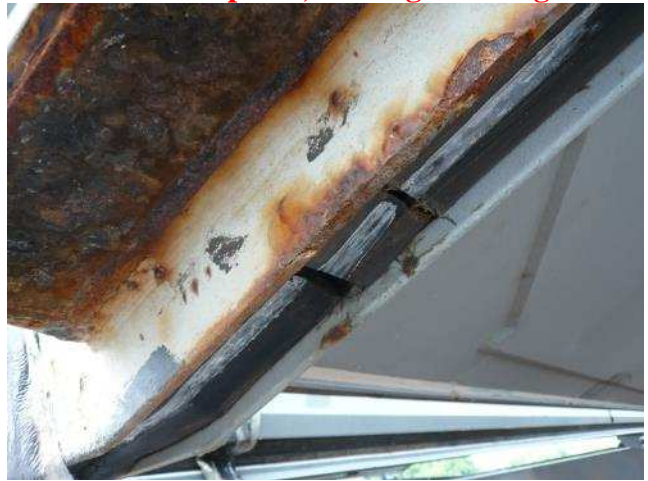
**Picture. No.16 – improper repair**

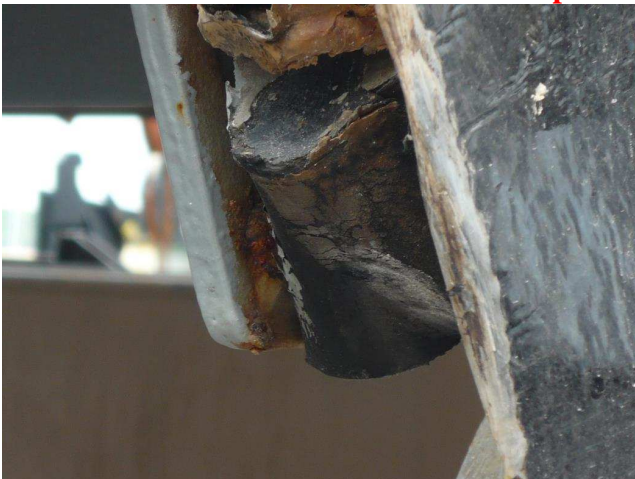
**Pict. No.17 - rubber corner damaged & worn**

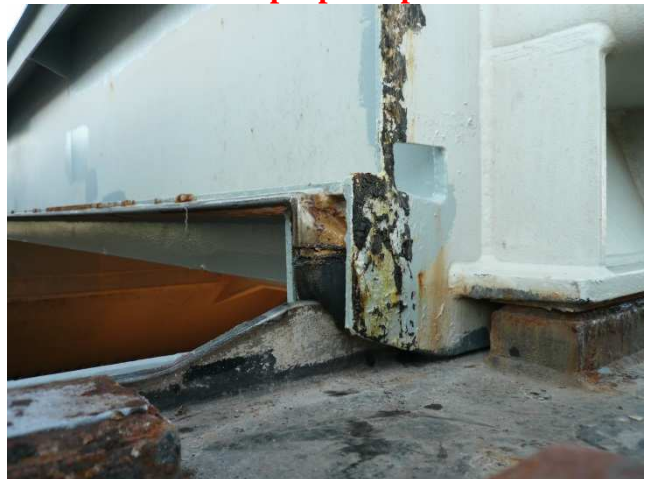
**Pict. No.18 - rubber corner damaged & worn**

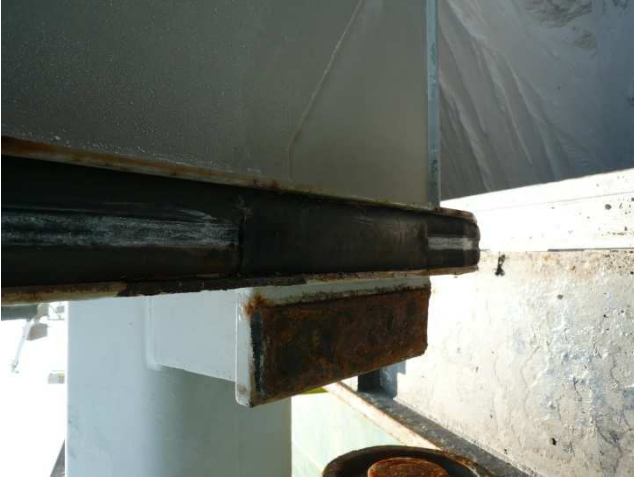
**Pict. No.19 – Repaired linear gasket stbd**

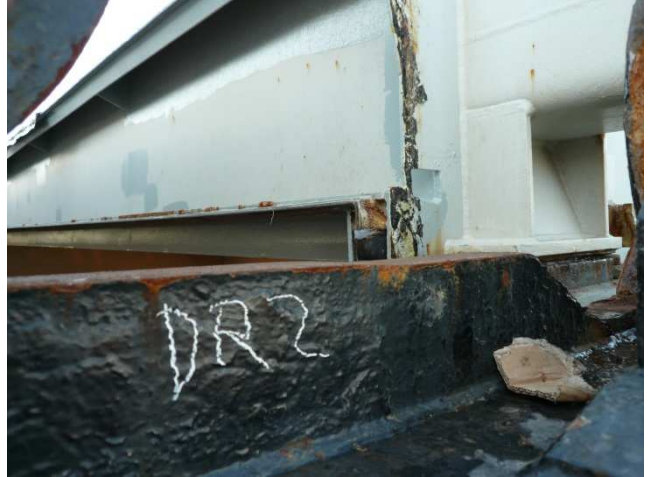
**Picture No.20 – Temporary repairs on corner**

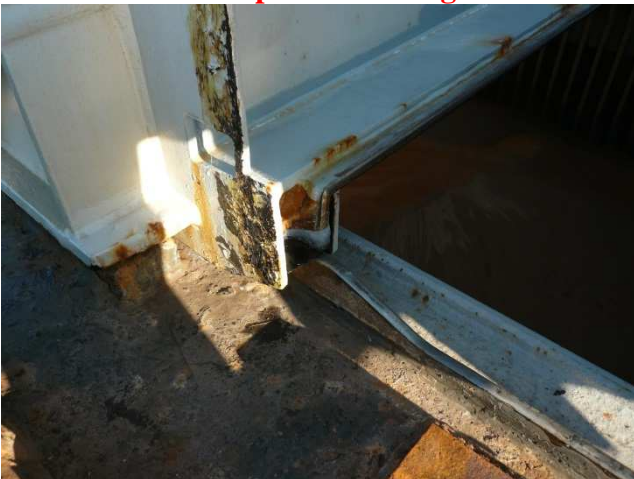
**Picture No.21 – Temporary repairs on corner**

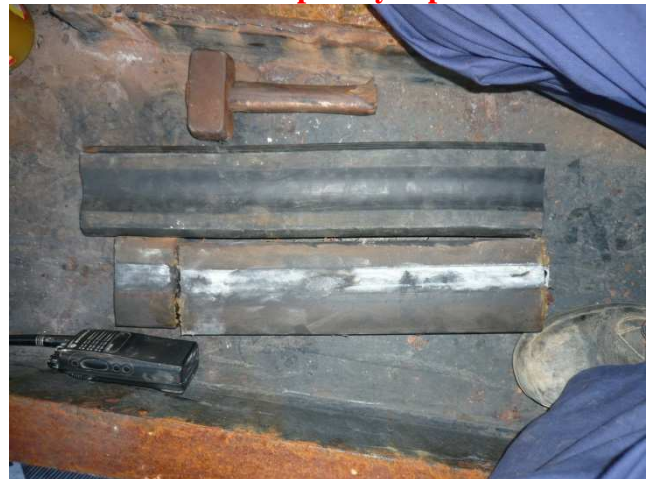
**Pict. No.22 – new linear gasket for the repair on 2<sup>nd</sup> panel port side**

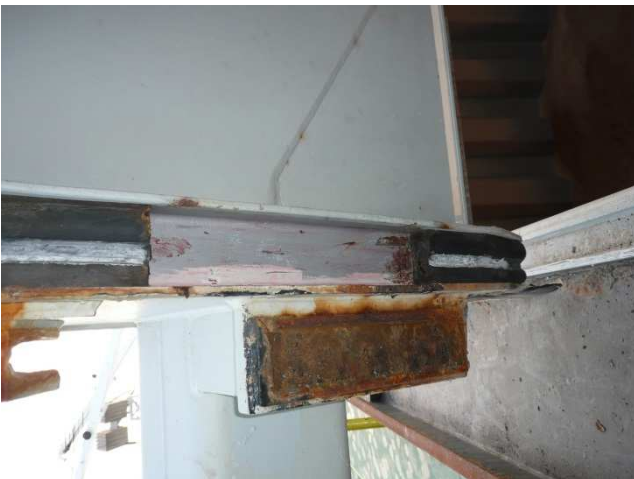
**Pict. No.23 – 2<sup>nd</sup> panel port side surface preparation of rubber channel.**

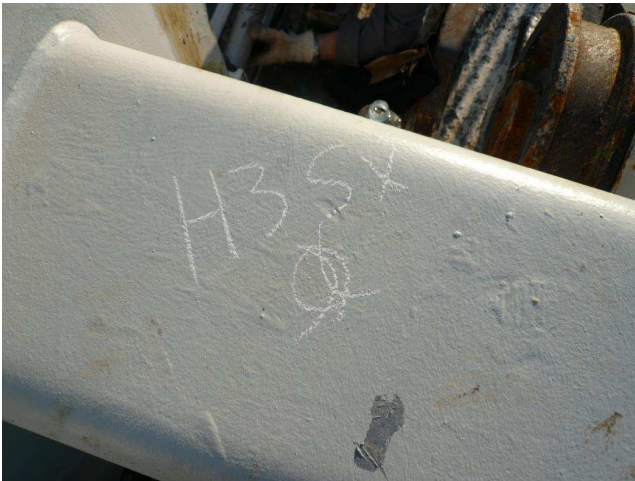
**Picture No.24 - C.H. No.3 Port side 2<sup>nd</sup> panel**

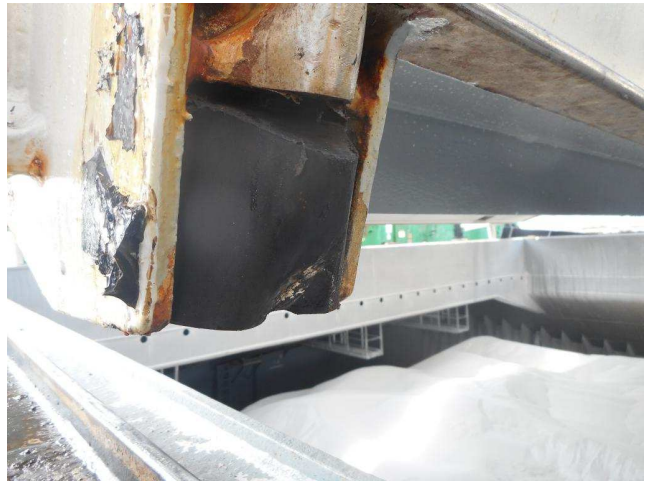
**Pict. No.25 – rubber corner damaged & worn**

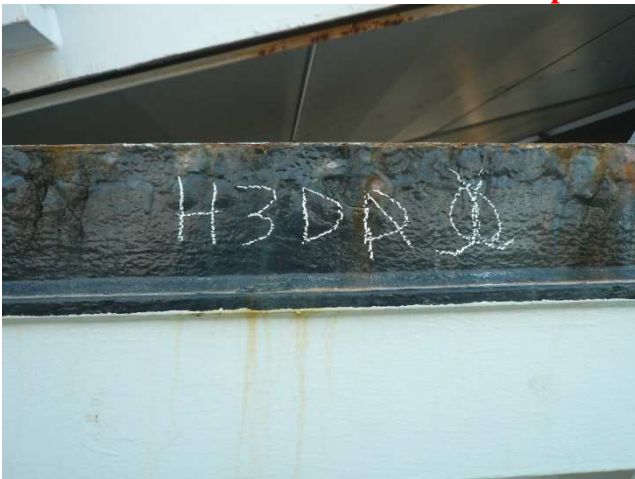
**Picture No.26 - C.H. No.3 Stbd side 2<sup>nd</sup> panel**

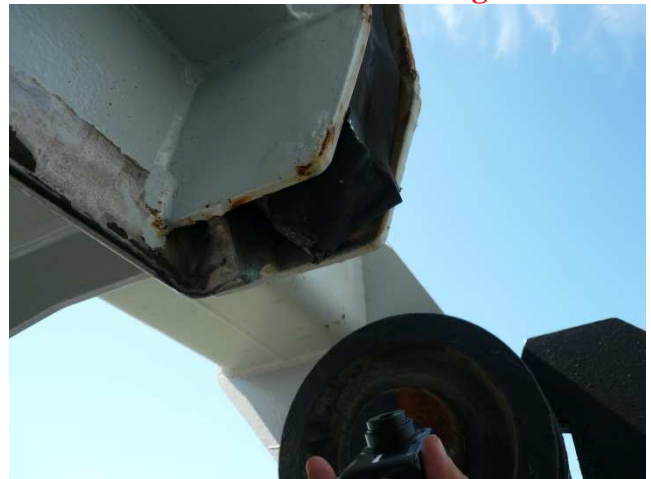
**Pict. No.27 – rubber corner damaged & worn**

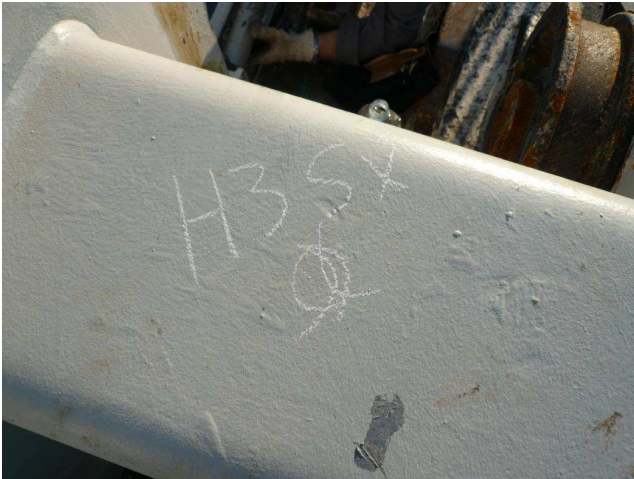
**Picture No.28 - C.H. No.3 Port side 2<sup>nd</sup> panel**

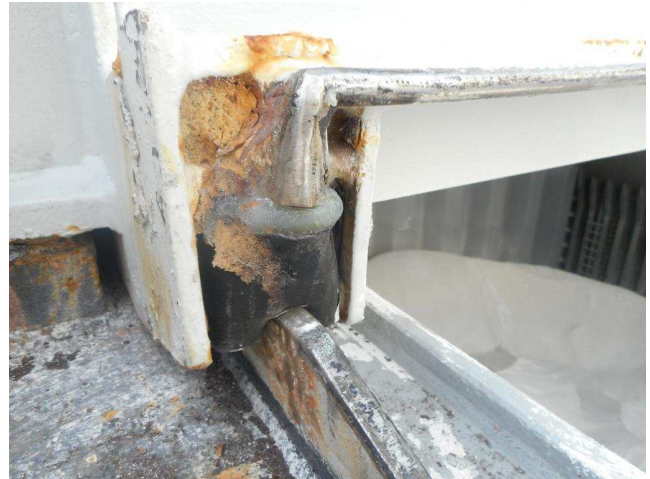
**Pict. No.29 – Temporary repairs on corner**

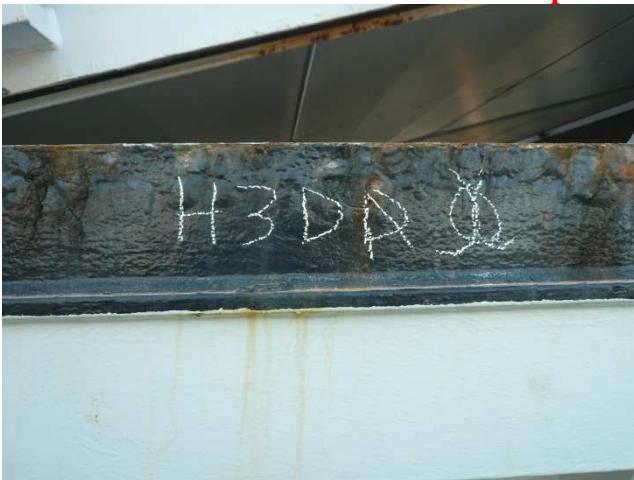
**Picture No.30 - C.H. No.3 Port side 2<sup>nd</sup> panel**

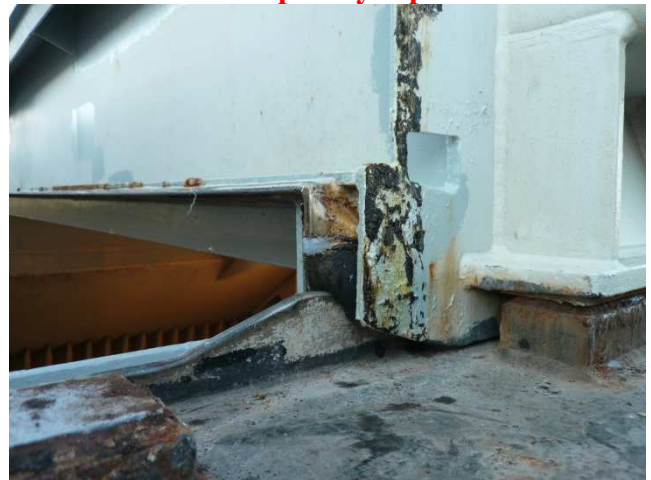
**Pict. No.31 – Temporary repairs on corner**

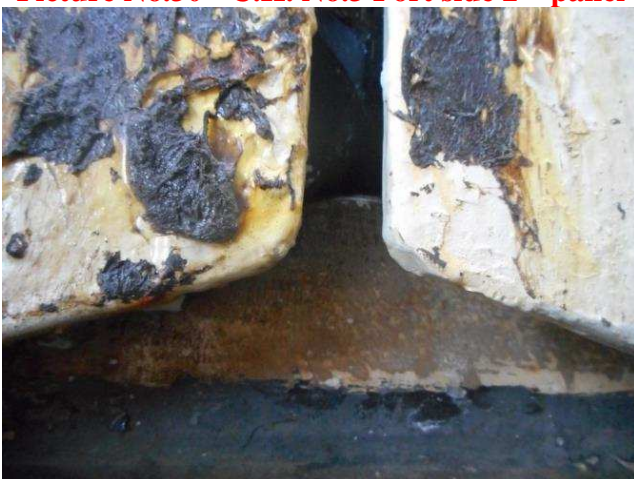
**Pict. No.32 - Light of abt 1 mm present between the two corners.**

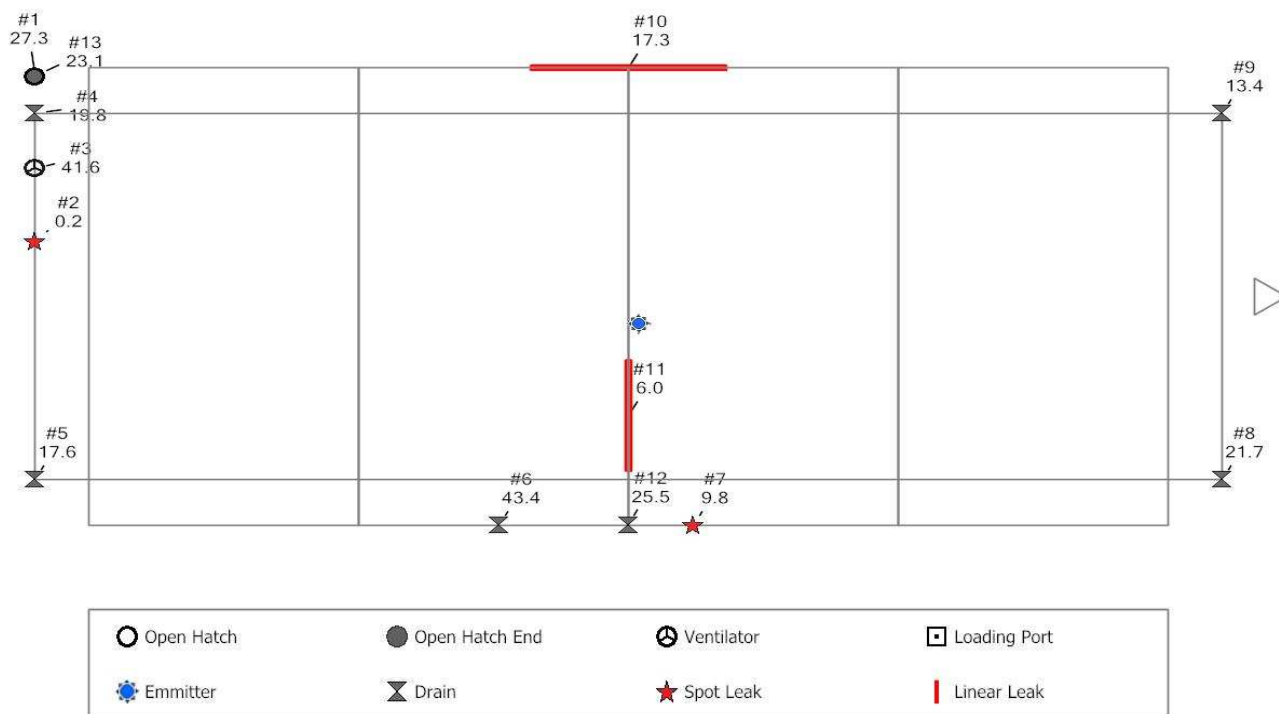
#	Leak type	dBμV	A	Sensor #	Date/Time measure (LT)	Comment
1	Open Hatch	27.3	70	1151104	2016-05-12 20:03	
2	Spot Leak	0.29	80	1151104	2016-05-12 20:07	TEST NOT PASSED
3	Ventilator	41.6	70	1151104	2016-05-12 20:09	TEST NOT PASSED
4	Drain	19.8	70	1151104	2016-05-12 20:10	TEST PASSED
5	Drain	17.6	70	1151104	2016-05-12 20:11	TEST PASSED
6	Drain	43.4	50	1151104	2016-05-12 20:13	TEST PASSED
7	Spot Leak	9.8	80	1151104	2016-05-12 20:14	TEST NOT PASSED
8	Drain	21.7	80	1151104	2016-05-12 20:16	TEST PASSED
9	Drain	13.4	90	1151104	2016-05-12 20:18	TEST PASSED
10	Linear Leak	17.3	80	1151104	2016-05-12 20:22	TEST NOT PASSED
11	Linear Leak	6.0	90	1151104	2016-05-12 20:27	TEST NOT PASSED
12	Drain	25.5	70	1151104	2016-05-12 20:32	TEST PASSED
13	Open Hatch End	23.1	70	1151104	2016-05-12 20:35

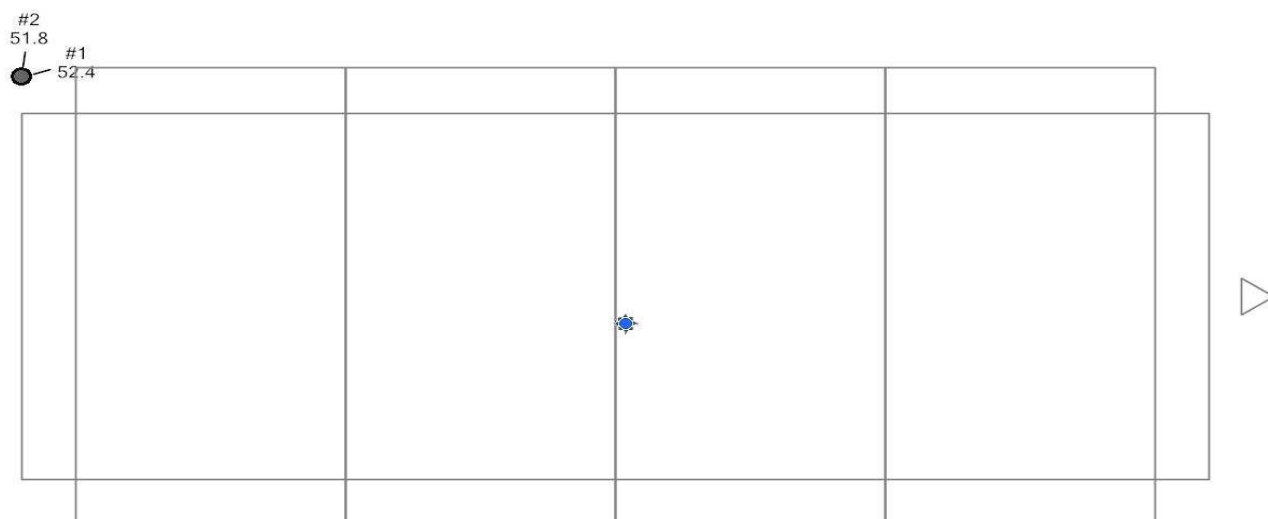
Open Hatch	Open Hatch End	Ventilator	Loading Port
Emitter	Drain	Spot Leak	Linear Leak

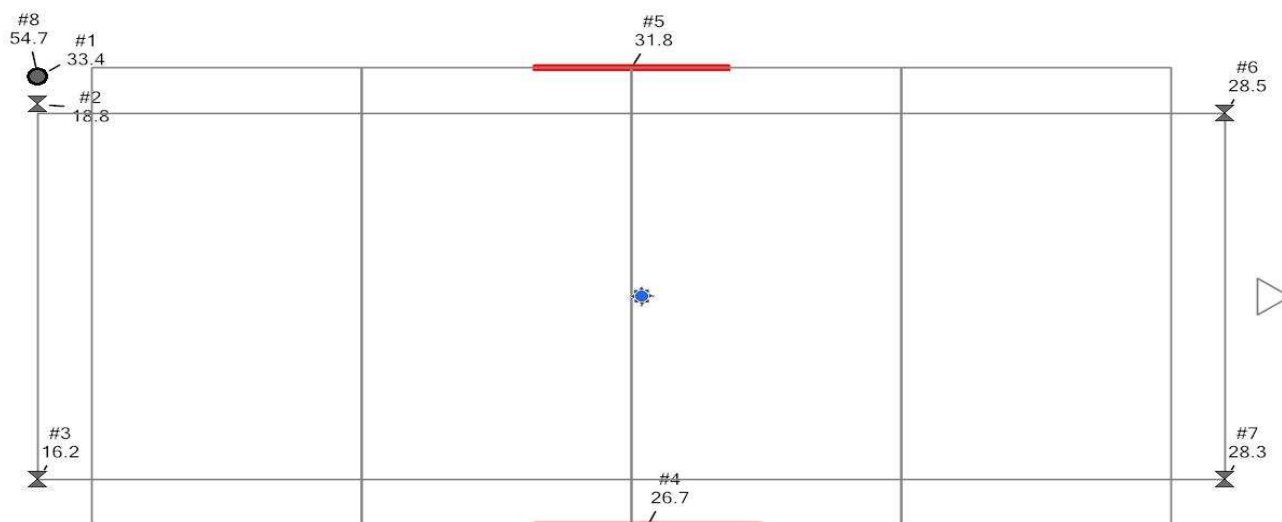
Open Hatch	Open Hatch End	Ventilator	Loading Port
Emitter	Drain	Spot Leak	Linear Leak

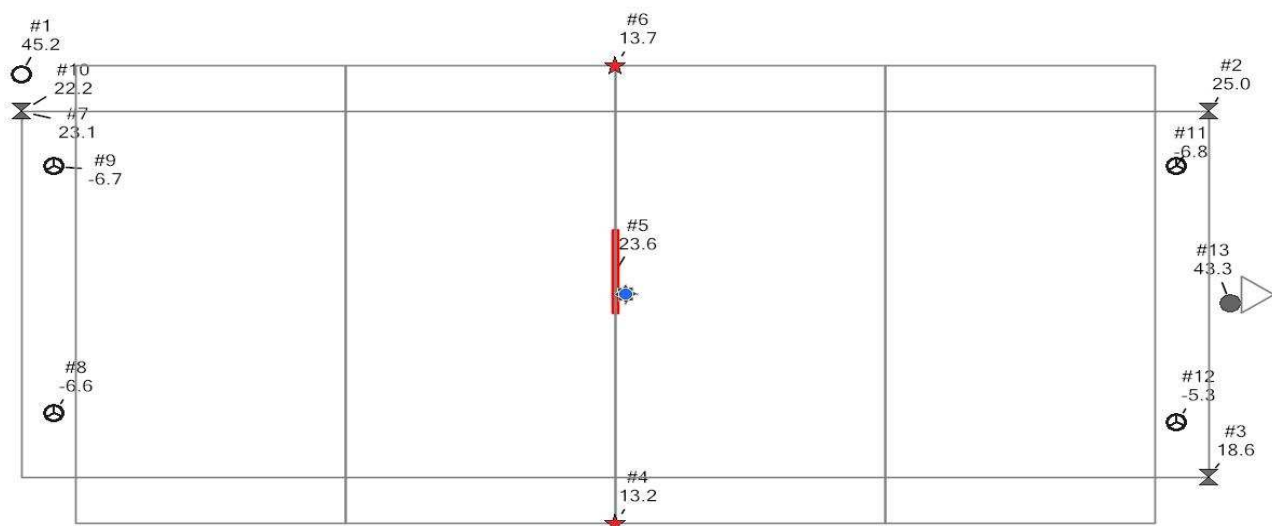
Open Hatch	Open Hatch End	Ventilator	Loading Port
Emitter	Drain	Spot Leak	Linear Leak

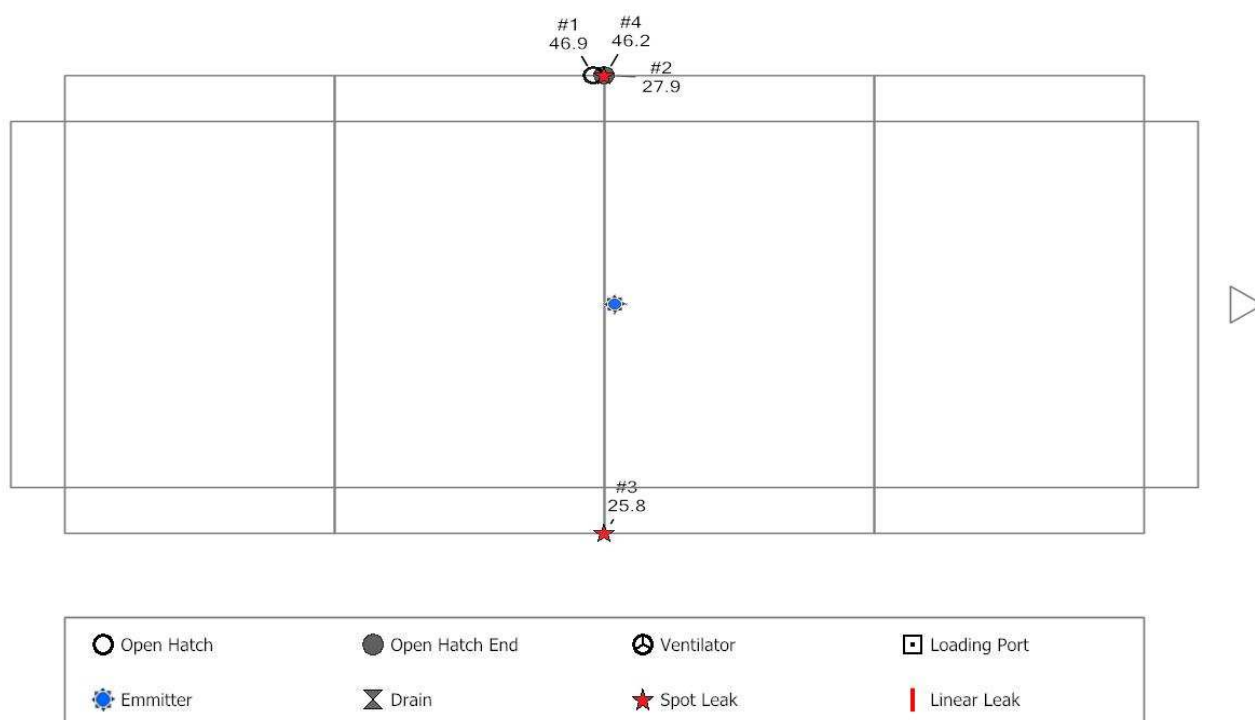
#	Leak type	dBµV	A	Sensor #	Date/Time measure (LT)	Comment
1	Open Hatch	46.9	50	1151104	2016-05-15 10:22	
2	Spot Leak	27.9	60	1151104	2016-05-15 10:24	LEAK REDUCED from linear to spot
3	Spot Leak	25.8	60	1151104	2016-05-15 10:25	LEAK REDUCED from linear to spot
4	Open Hatch End	46.2	60	1151104	2016-05-15 10:28

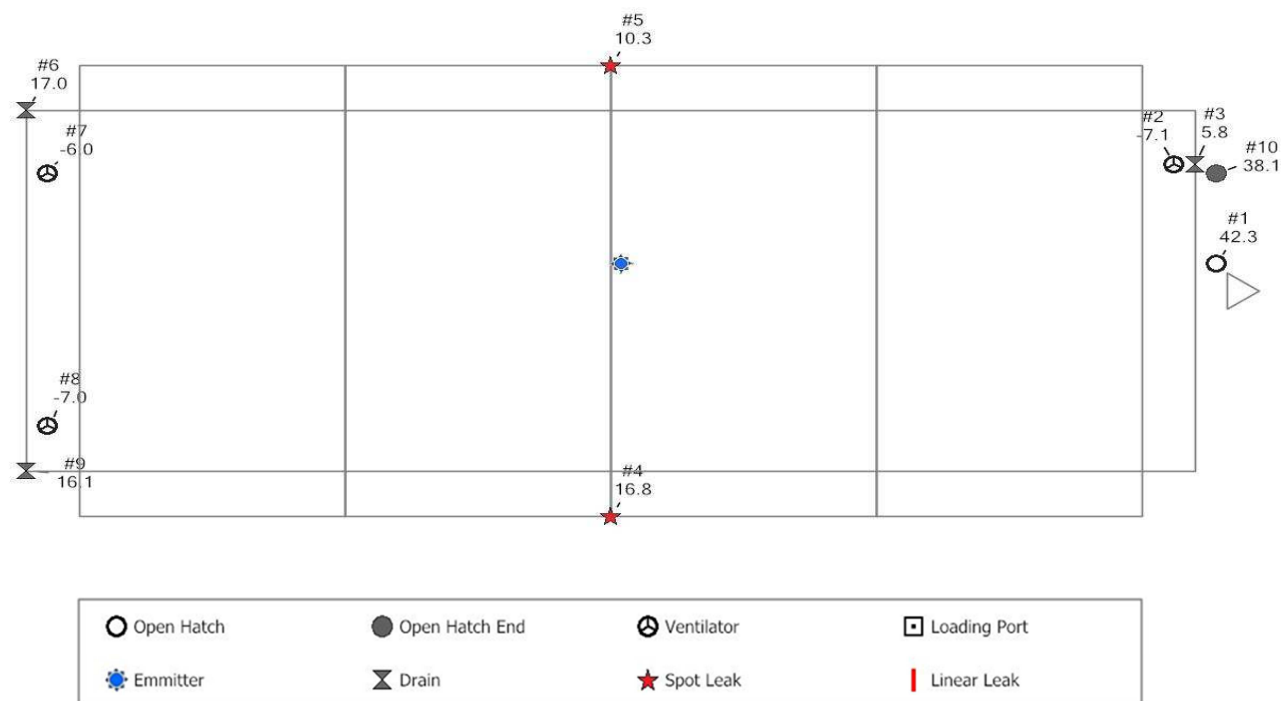
#	Leak type	dBμV	A	Sensor #	Date/Time measure (LT)	Comment
1	Open Hatch	42.3	50	1151104	2016-05-14 18:22	
2	Ventilator	0.1	90	1151104	2016-05-14 18:24	TEST PASSED
3	Drain	5.8	90	1151104	2016-05-14 18:24	TEST PASSED
4	Spot Leak	16.8	80	1151104	2016-05-14 18:27	TEST NOT PASSED
5	Spot Leak	10.3	90	1151104	2016-05-14 18:28	TEST NOT PASSED
6	Drain	17.0	80	1151104	2016-05-14 18:32	TEST PASSED
7	Ventilator	0.0	80	1151104	2016-05-14 18:32	TEST PASSED
8	Ventilator	0.0	90	1151104	2016-05-14 18:33	TEST PASSED
9	Drain	16.1	90	1151104	2016-05-14 18:34	TEST PASSED
10	Open Hatch End	38.1	60	1151104	2016-05-14 18:36

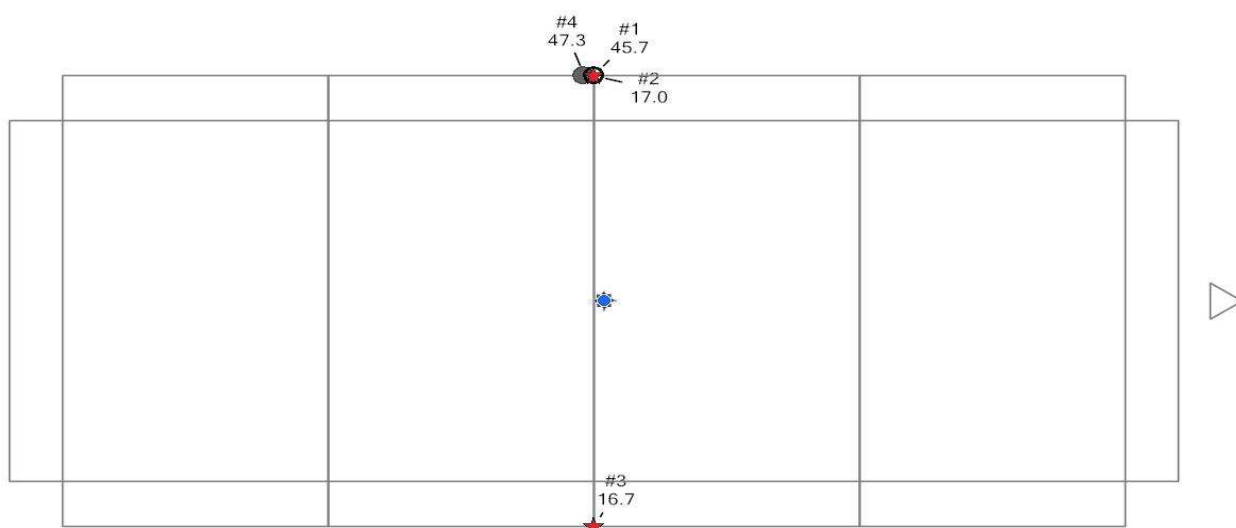
#	Leak type	dBµV	A	Sensor #	Date/Time measure (LT)	Comment
1	Open Hatch	45.7	50	1151104	2016-05-15 10:42	
2	Spot Leak	17.0	70	1151104	2016-05-15 10:44	TEST NOT PASSED
3	Spot Leak	16.7	80	1151104	2016-05-15 10:45	TEST NOT PASSED
4	Open Hatch End	47.3	70	1151104	2016-05-15 10:46
