## SURVEY REPORT

- Machinery apparatus and electric system by vibration analysis method, with thermographic control and power quality control.

| INFRARED THERMOGRAPHIC CONTROL ON AUXILIARY GENERATOR No. 2 | | |

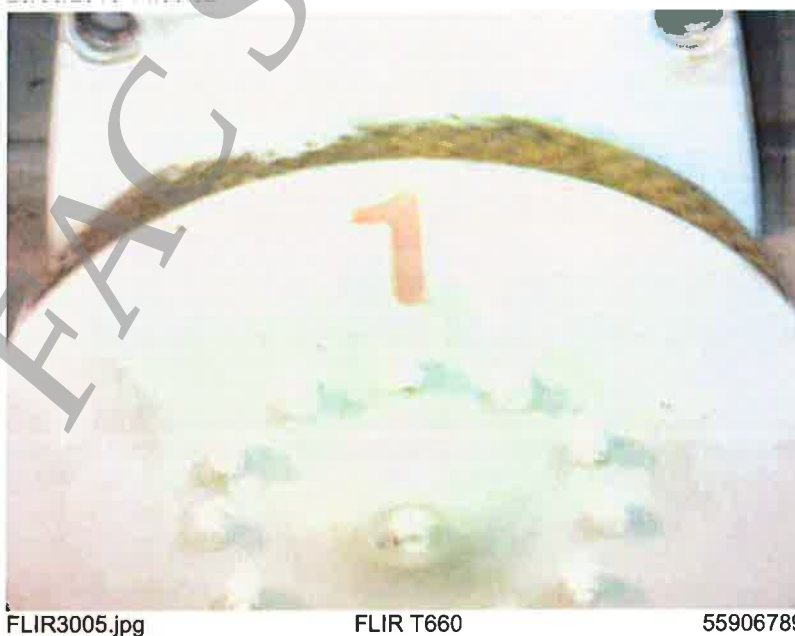
| ITEM: | COMMENT: |
|---|---|
| MAIN BEARINGS | All found in order no overheating parts found, average temperature around 85/88 °C see picture details. |
| CONNECTING ROD BEARINGS | All found in order no overheating parts found, average temperature around 85/88 °C see picture details. |

## Measurements °C

Sp1 65.1

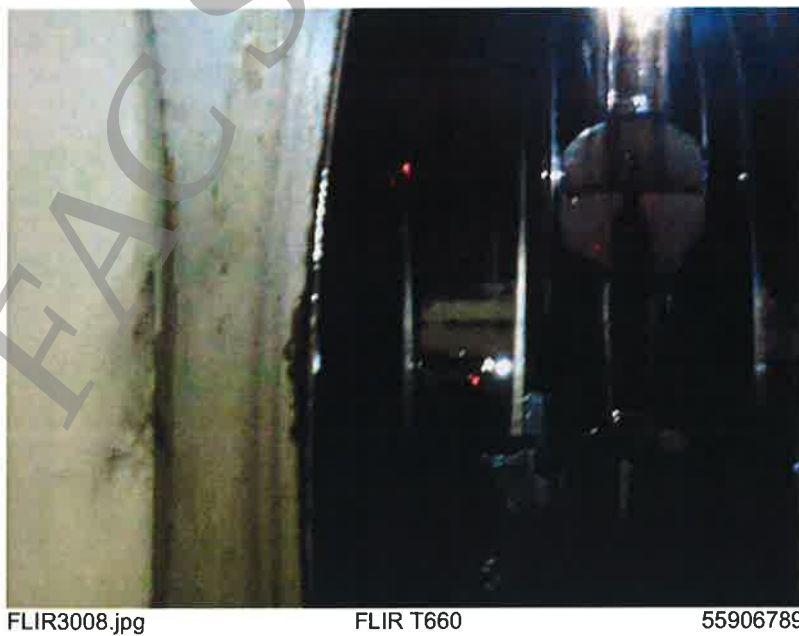
| Li1 | MAIN BEARING No.7 |

| REFERENCE | ITEM | AVERAGE<br>TEMP. °C | OPERATIVE<br>ΔT | CRITICAL T<br><b>ALARM</b> | RESULT |
|---|---|---|---|---|---|
| LINE 1 | MAIN BEARING No. 7 | 85.7 | N.A. | 100°C | GOOD |

## Measurements °C

| Li1 | Max | 85.5 |
| | Average | 84.7 |

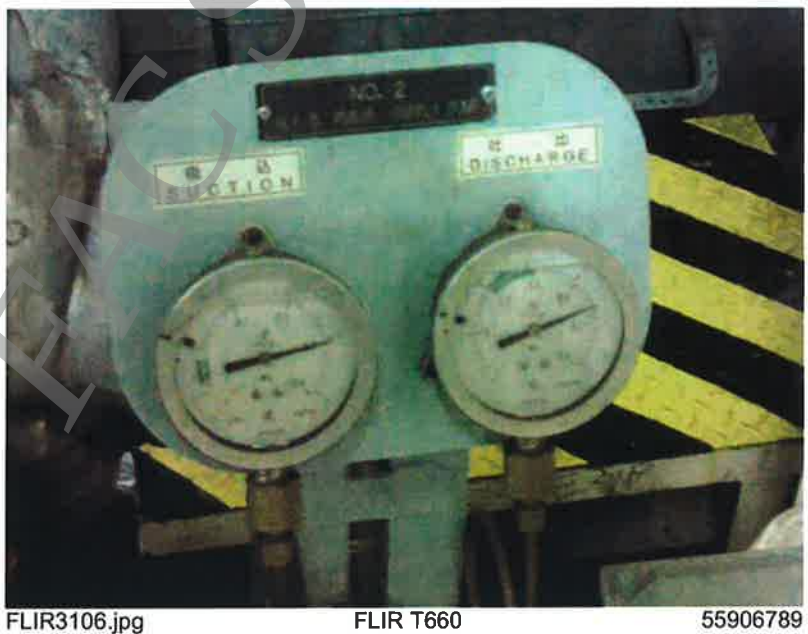
| ITEM: | COMMENT: |
|---|---|
| ELECTRIC MOTOR | Distribution of temperature found uniform no evidence of overheating parts. |
| PUMP | Range of temperature normal, no evidence of leaking. |

| All parts inspected found in order. |

Sp1 39.2

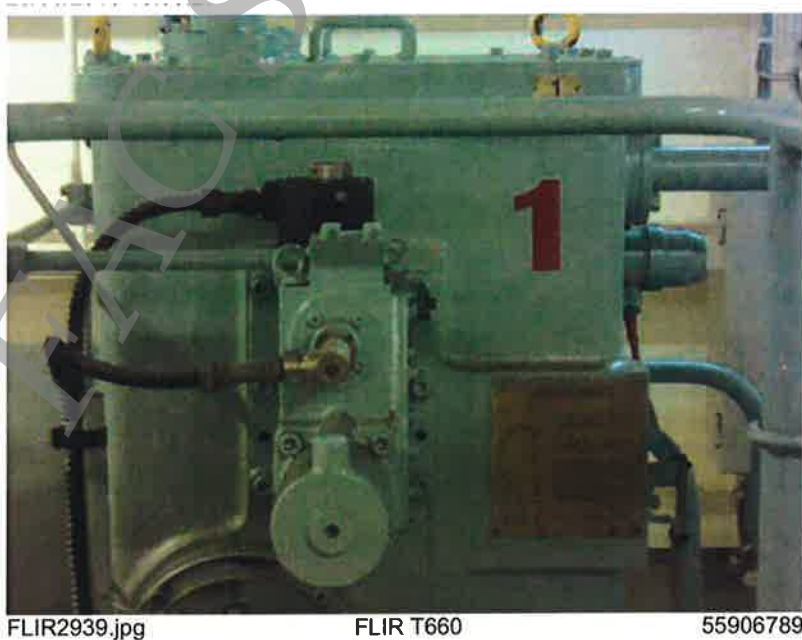
| ITEM: | COMMENT: |
|---|---|
| ELECTRIC MOTOR | Distribution of temperature found uniform no evidence of overheating parts. |
| PUMP | Range of temperature normal, no problems to be reported. |

| All parts inspected found in order. |
